UNIVERSITY REPORT ON AIR FILTER TESTING

**By John Waanders, Laboratory Manager,
University Of Newcastle NSW 2308**

AS USED BY HUNTER VALLEY FILTER SALES

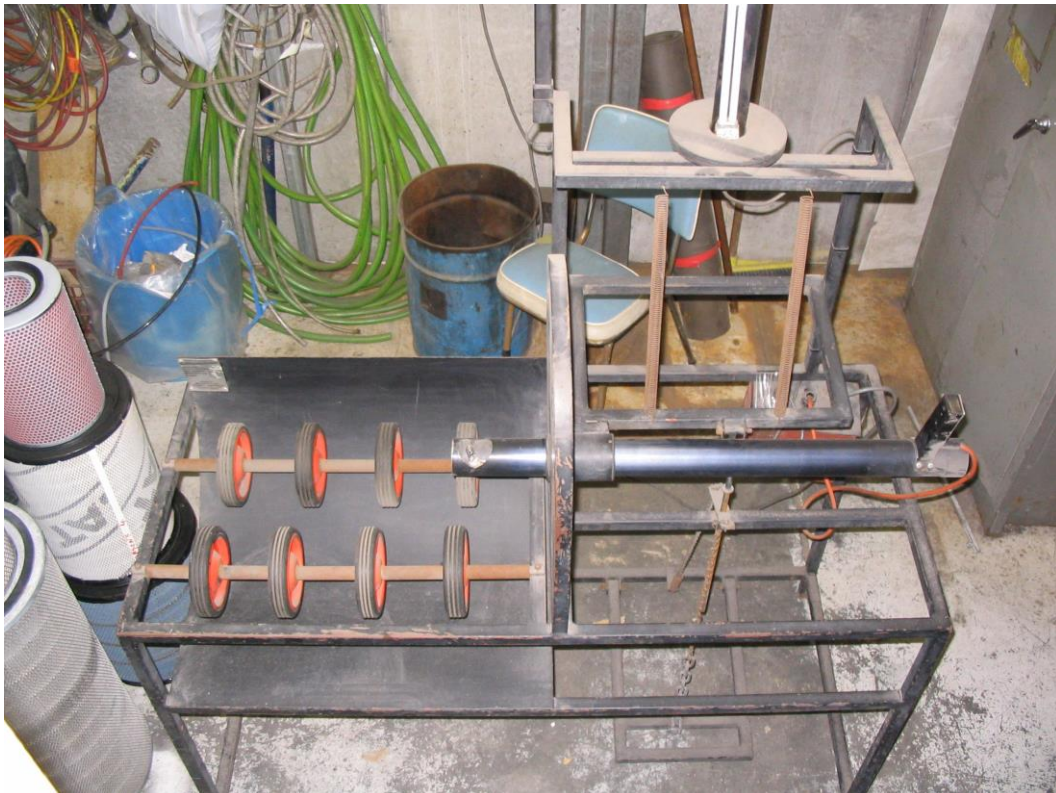
The light testing device as shown above, is a commercial unit manufactured by Vibramatic Systems and designed by Erican Pty Ltd. This method depends on the experience of the operator to be able to detect variations in brightness through the filter material.

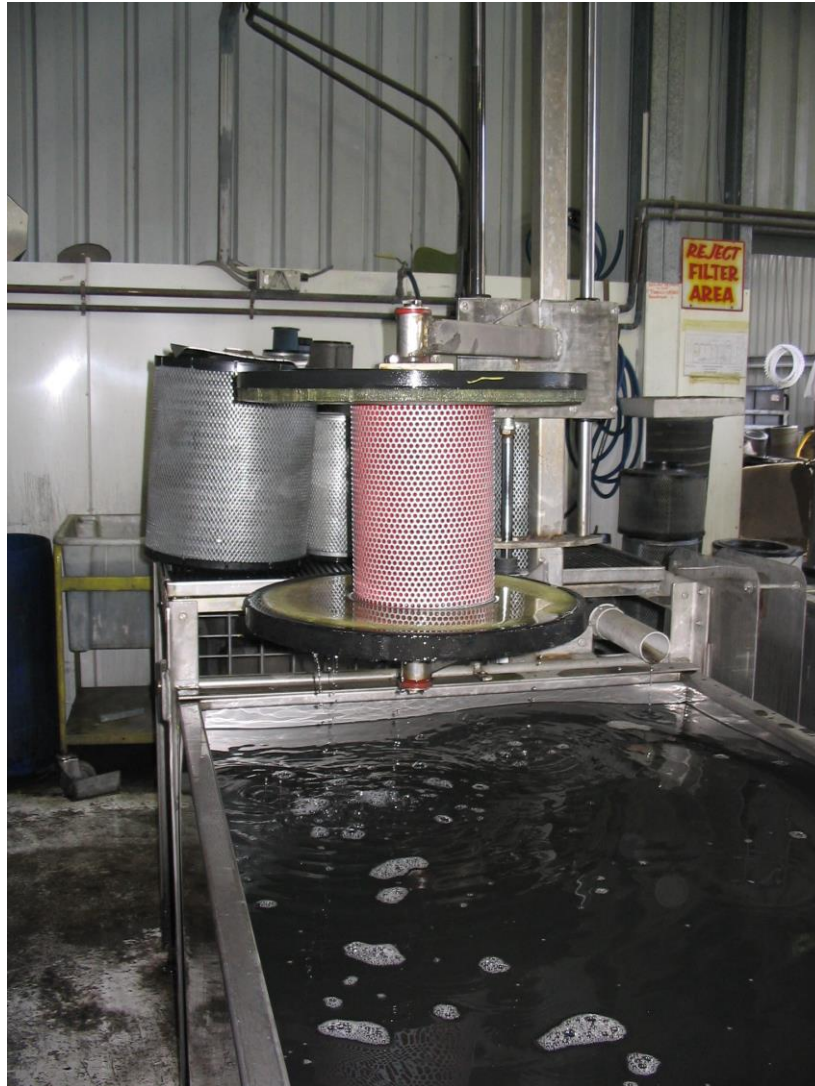
During the water leak test the filter is placed in a clamp such that it is sealed at each end and it is then immersed in a tank of water and is rotated. A picture of the water test device is shown below. This device has been manufactured by HVFS.

The air trapped within the filter can only escape through holes in the filter material so that if there are not any leaks bubbles rising from the filter would be very fine and would depend on the filter porosity. If there are perforations in the filter material the air will escape to form larger bubbles which are easily detectable by the operator.

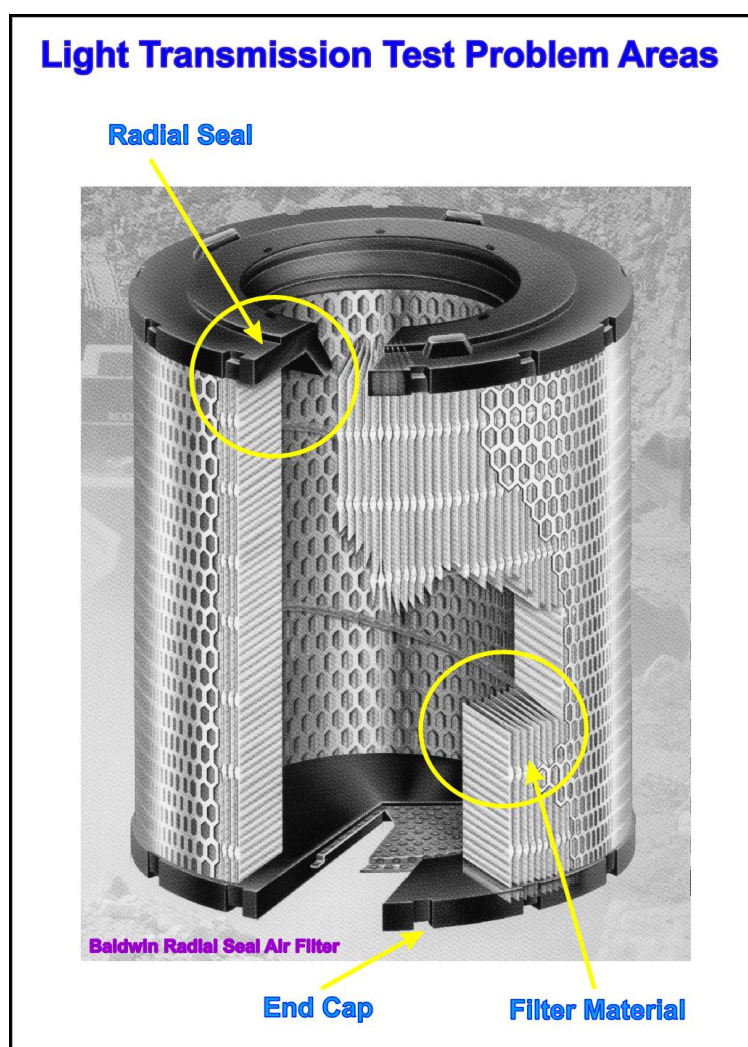
FIGURE 1

The other main point discussed using this method was the concern about light not being able to penetrate around bends to identify holes or perforations. To explain these in more detail consider the areas highlighted in Figure 1:

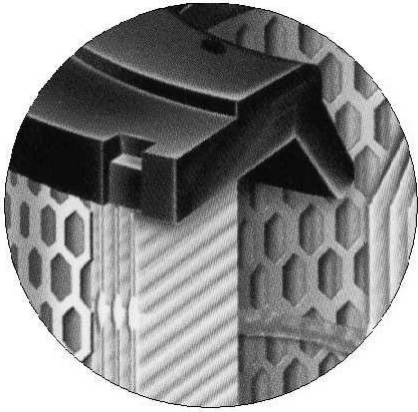
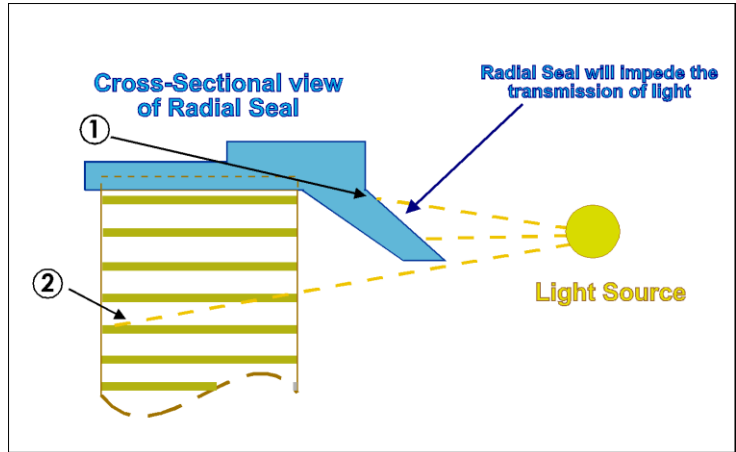
DIAGRAM 1

Diagram 1 illustrates how the light source cannot be positioned to allow light to pass the seal, nor will it allow the light to enter the top section where the top of the filter material is enclosed by the radial seal end as shown at ①. The light source to be effective needs to be able to pass into the filter material as shown at ②.

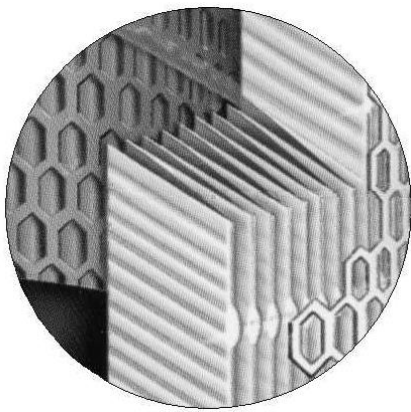
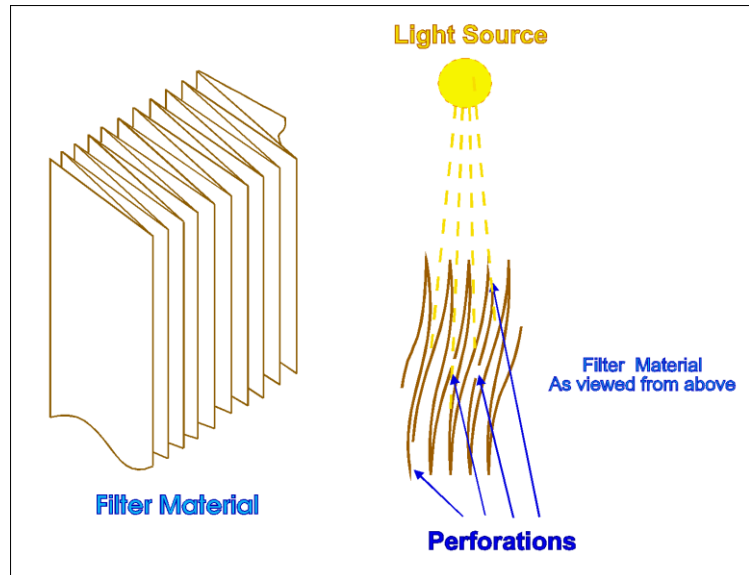
DIAGRAM 2

Diagram 2 illustrates the possibilities of holes or perforations being missed by the transmitted light. The diagram has been drawn showing a cross-section of the filter material as viewed from above. Perforations may occur at the folds or in the middle sections of the filter material but if there is any distortion of the filter material then the light will not be able to negotiate the turns to allow the transmitted light to be detected.

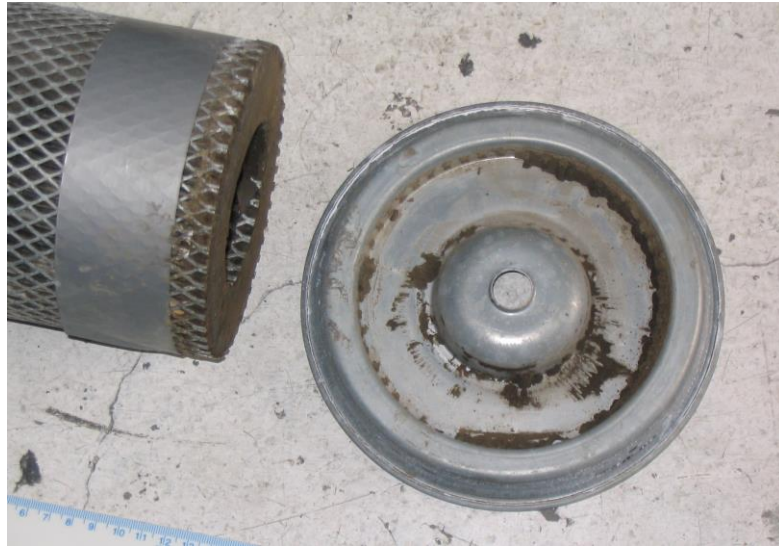
PICTURE 1

Picture 1 shows a filter with an end cap removed. This filter had shown considerable leaks with the water test method; these leaks were not detected with the light transmission method.

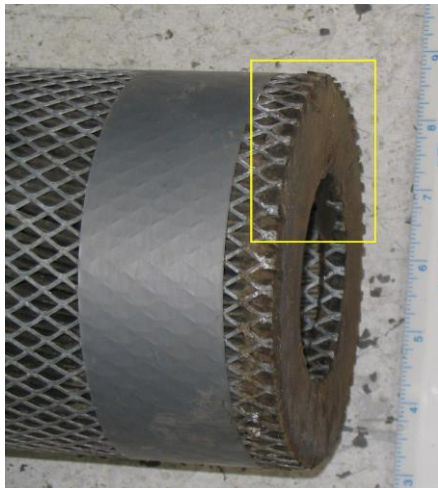
PICTURE 2

Picture 2 is a closer view of the end of the filter and the highlighted section has been enlarged in Section 3.

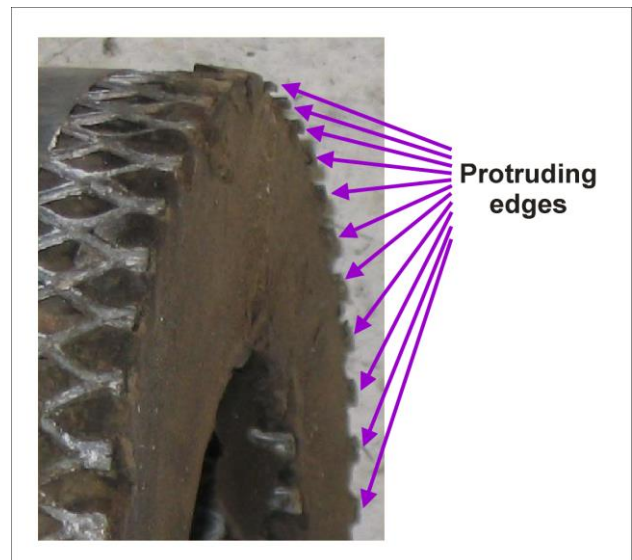
SECTION 3

It is clear from the close-up shot that the protruding edges of the wire frame were hindering a neat seal of this end cap. What has occurred is that the sealing rubber material has shrunk or shifted during use and has created a gap between the inner and outer sections of the Filter. Any light that enters this area will be shielded by the end cap, indicating that the end cap is hole free, yet there is clear proof that air entering the filter will by-pass any filter medium.

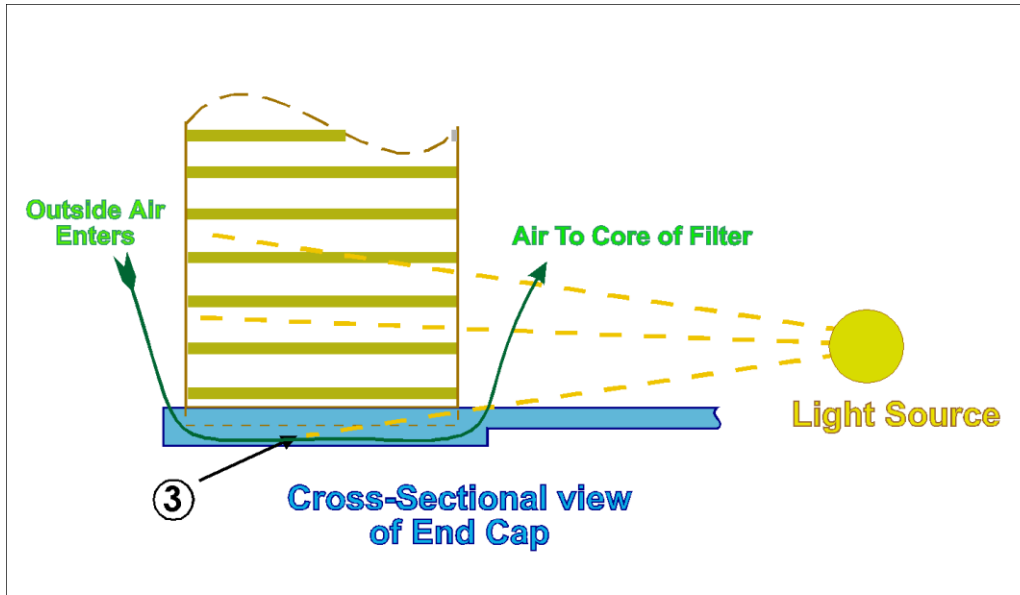
DIAGRAM 3

Diagram 3 shows the effect of the light passing into the end cap region of the filter, and at the point indicated by ③ there is no exit point for the light to be detected. Air however can be drawn into the core of the filter through perforations in the end cap caused by the protruding edges of the filter framework.
